Navajo Abandoned Uranium Mine

Site Screen Report

Mine Name: A & B No. 7
Mine ID: 451

August 2011

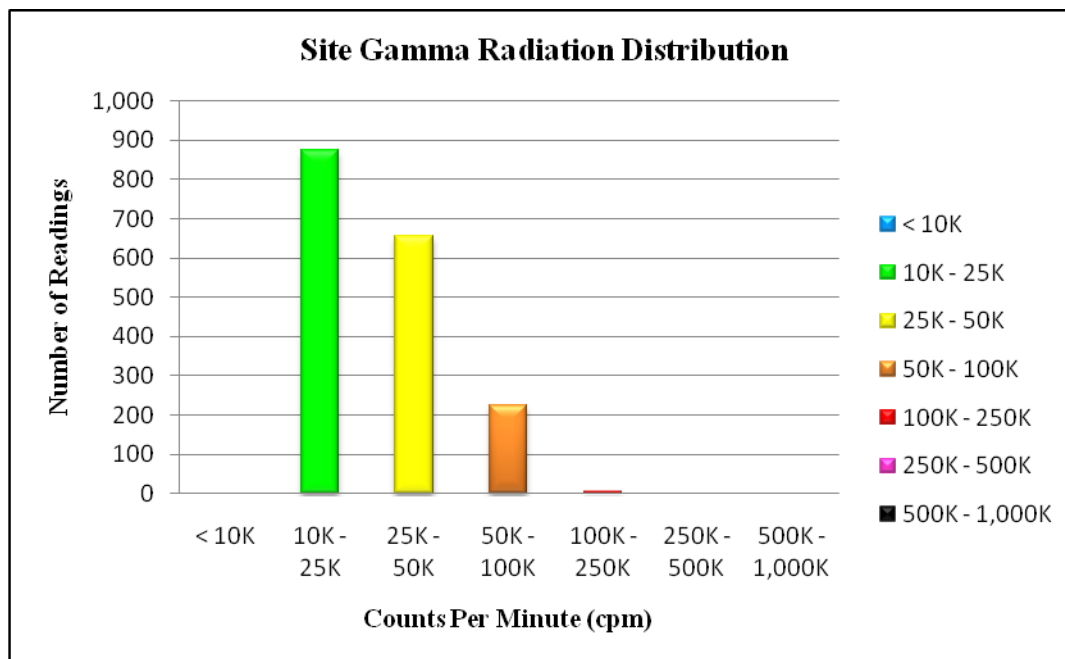
Distribution Chart and Statistics:

Site Gamma Radiation Statistics	
Number of Readings	1,762
Minimum (cpm)	12,538
Maximum (cpm)	121,666
Mean (cpm)	31,469
Median (cpm)	25,126
Standard Deviation	16,528

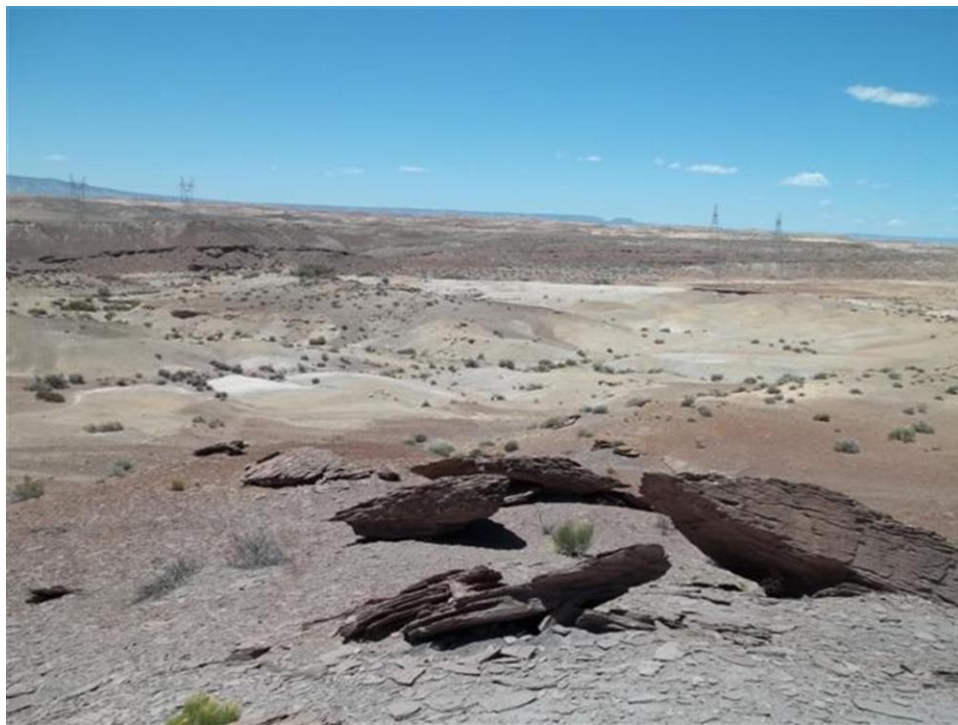
Photo 1: Mine Site #451

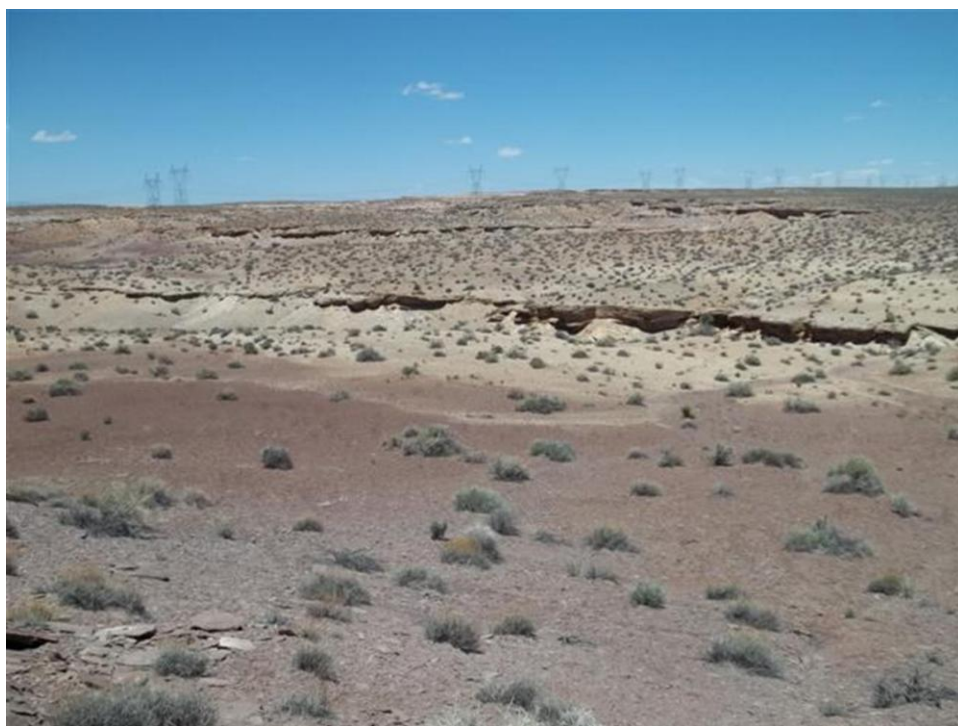
Photo 2: Mine Site #451

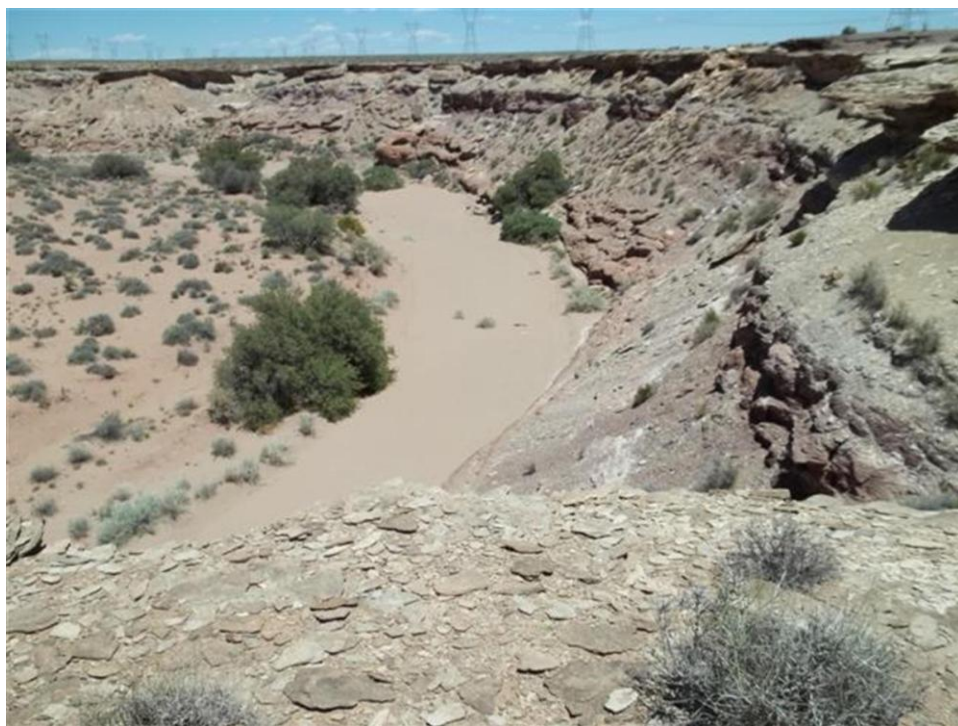
The site is located within a wash area which may contain seasonal tributaries to the Little Colorado River

Photo 3: Mine Site #451; Dry river bed north of site

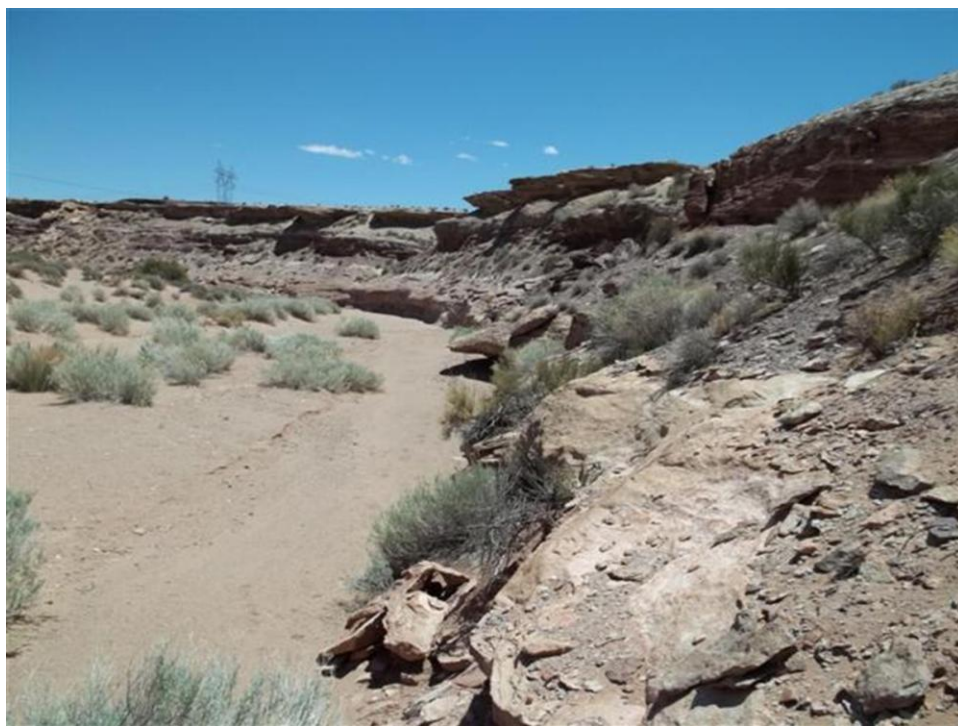
Photo 4: Mine Site #451; Dry river bed northwest of site

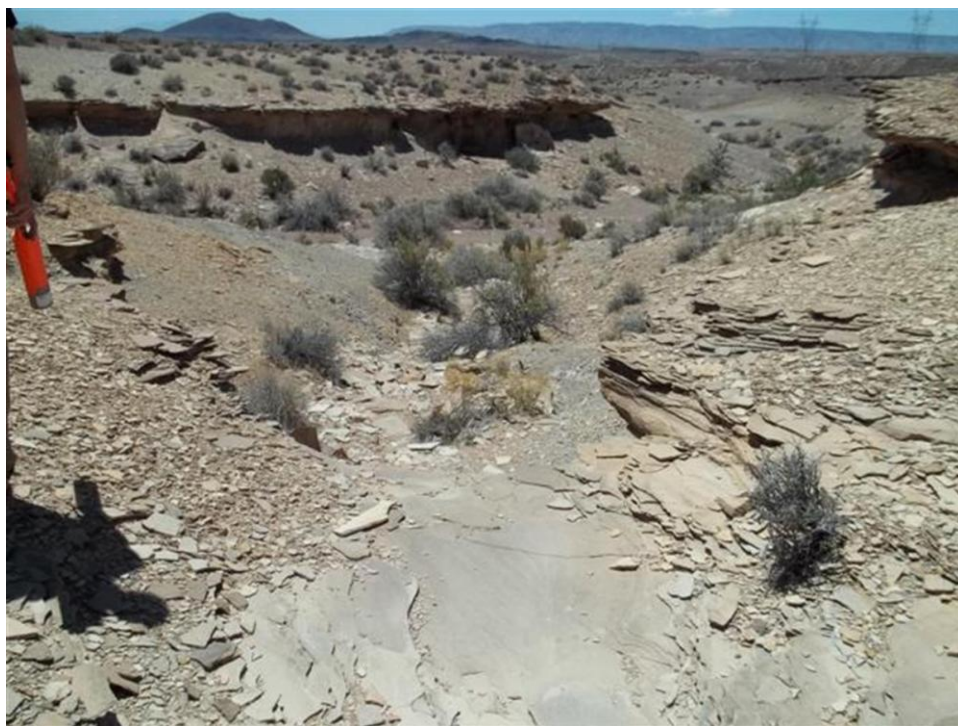
Photo 5: Mine Site #451; Drainage through site

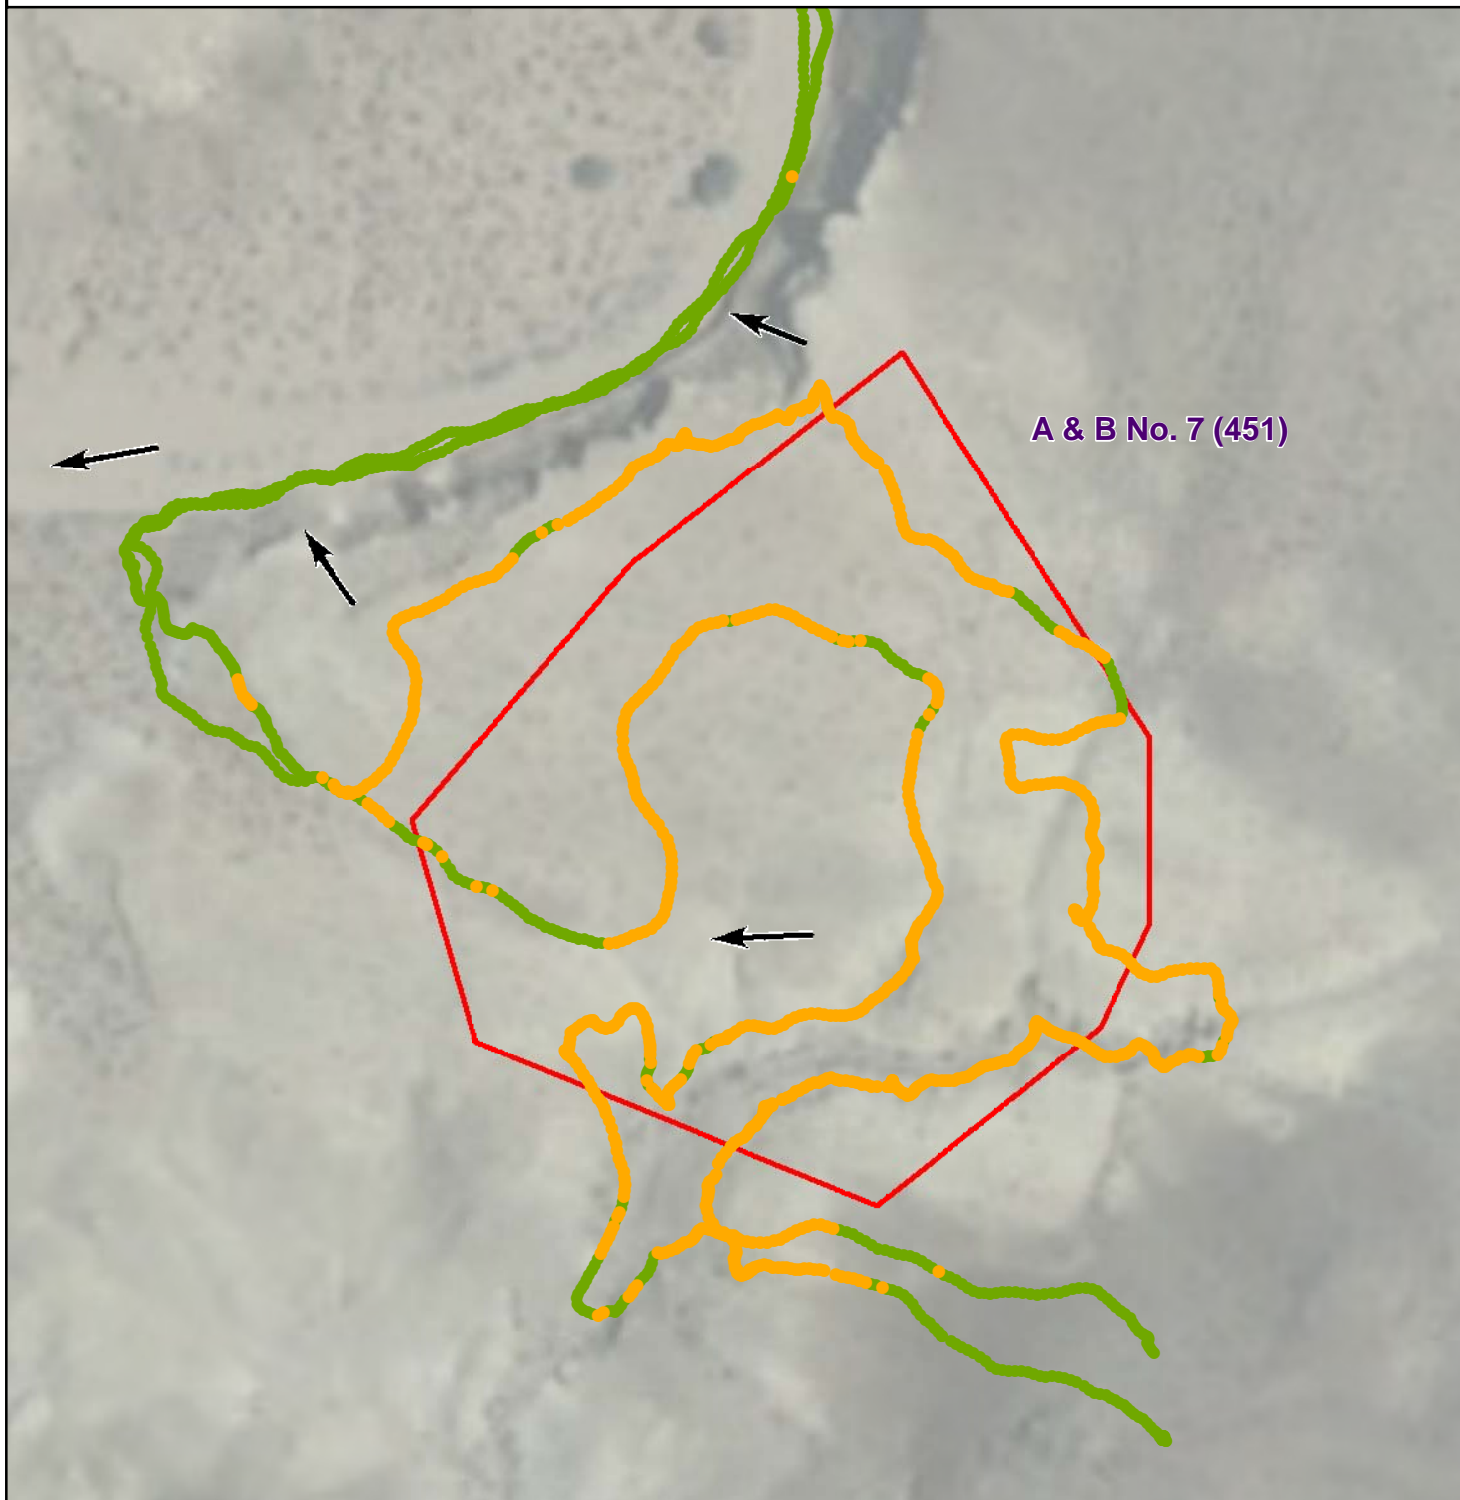
**Figure 1 - Gamma Radiation Measurements, Above Two Times Background
A & B No. 7 (451)
Bodaway / Gap Chapter, Navajo Nation**

A total of 1,762 gamma radiation measurements were collected from the mine site, ranging from 12,538 cpm to 121,666 cpm. The measurements are represented in Figures 1 and 2.

Average background 11,852 cpm

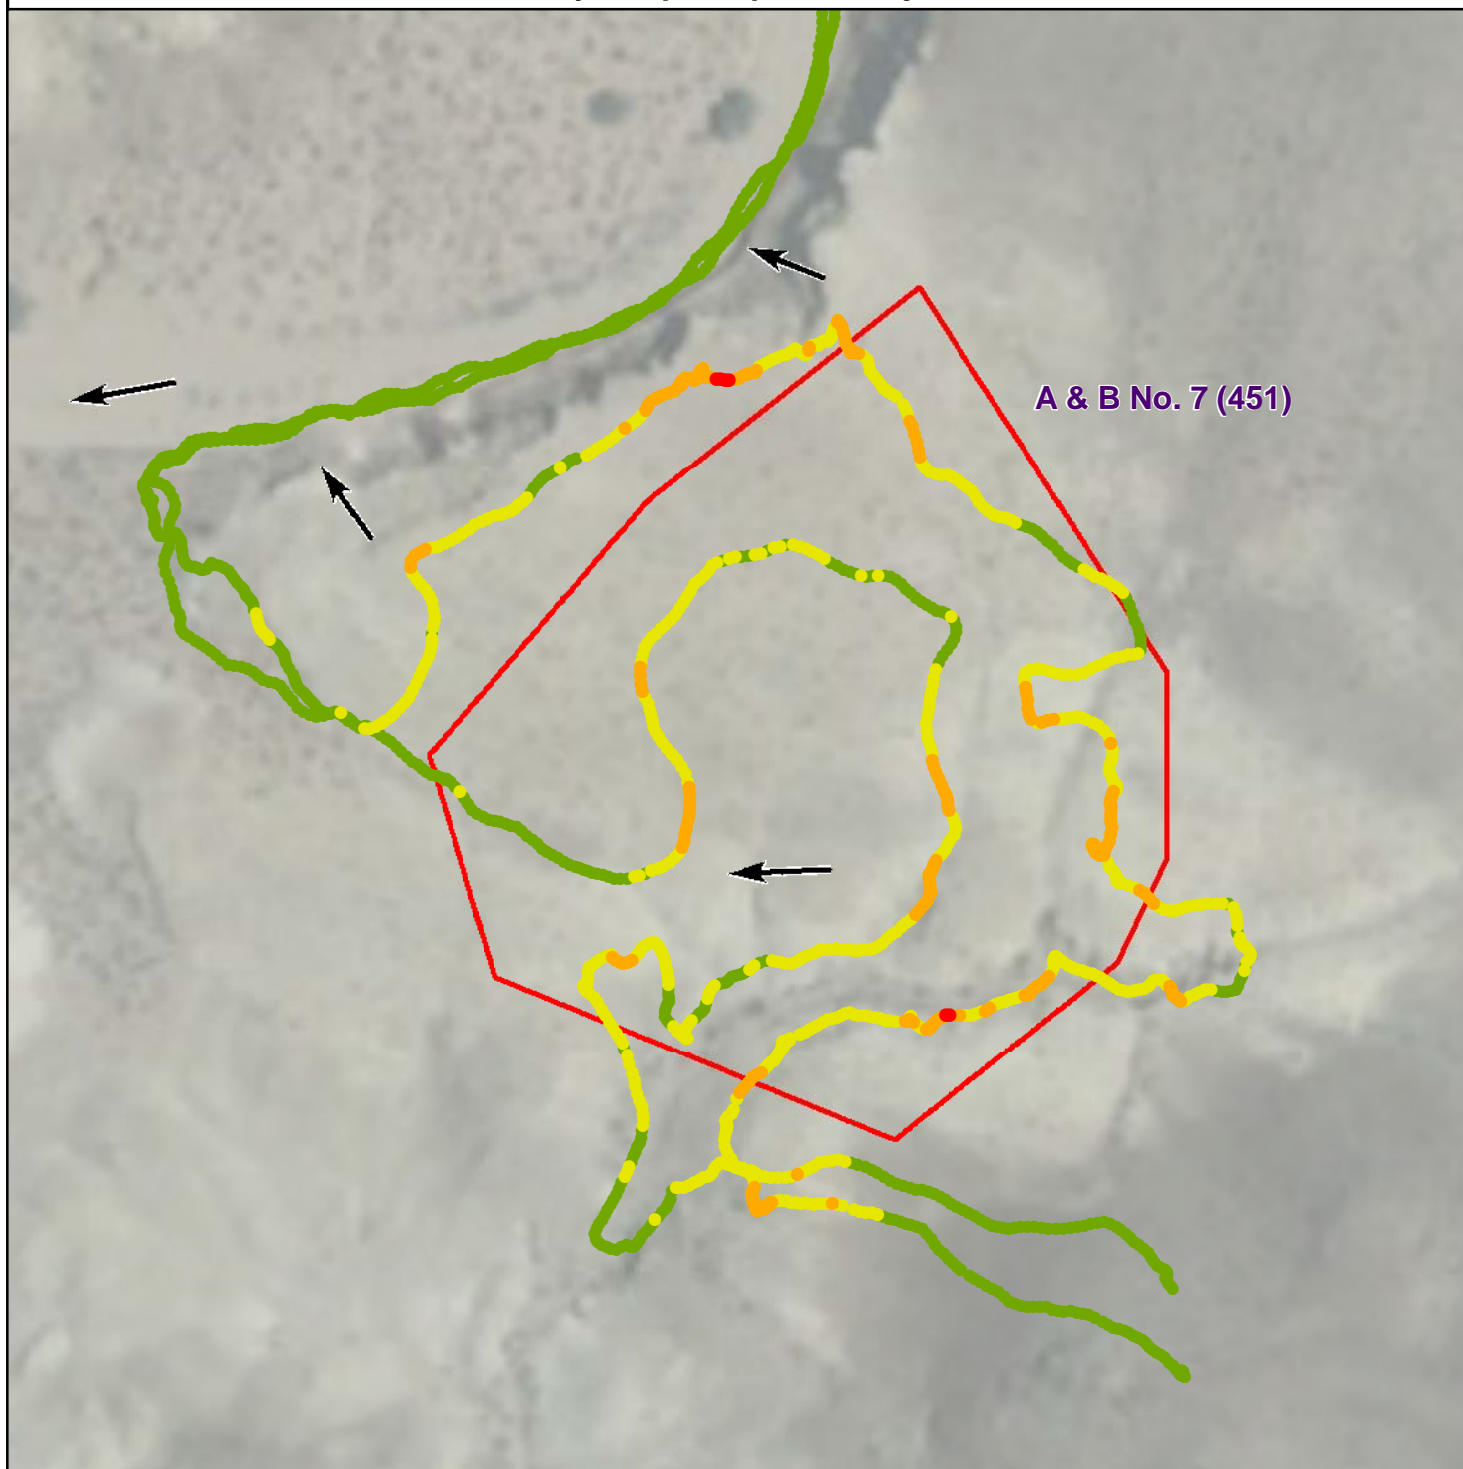
Figure 2 - Gamma Radiation Measurements
A & B No. 7 (451)
Bodaway / Gap Chapter, Navajo Nation

Measured as counts per minute (cpm) Average background 11,852 cpm
